There is Knowledge in Failure- If Followed by Root Cause Analysis

K. K. Vaze

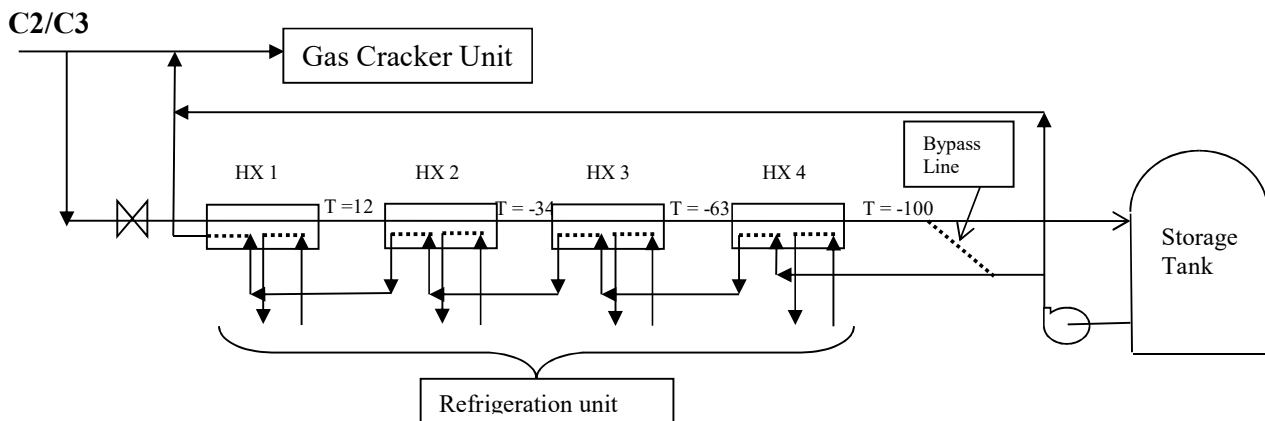
Fig. 1 Partial Flow Sheet

Incident: OSBL plant was being commissioned. First two stages of the four-stage chilling were commissioned successfully with chilling to -35 deg C. Ethylene refrigeration system was valved in for further chilling. Temperature dropped to -100 deg C. At that instant, massive leakage was observed forming a vapour cloud. There was an explosion followed by fire, extensive damage and loss of life. From the nature and spread of damage the source of initial leak could be pinpointed to one of the heat exchangers (HX 4 in Fig. 1).

The weld joining the aluminium flange to the nozzle at the suspected leakage location was found to be ruptured and metallurgical examination showed poor quality weld with extensive interpass porosity. However stress and fracture analyses showed that even the poor quality weld should have survived the operating stress once it passed the hydrotest because the operating stress is lower.

The piping uses low alloy steel studs for joining an aluminium flange to a carbon steel flange. The studs were tightened at room temperature and temperature was then lowered. The differential contraction between the flanges and studs, caused by the large difference in thermal expansion coefficient of aluminium and carbon steel, led to reduction in the gasket compression which in turn caused leakage. In support for this hypothesis, the following extract from Appendix XII of ASME Code Sec. III [5] can be cited:

In view of the two facts: i) The leakage quantity in the tests was not substantial and ii) Whether the failed weld was the cause of the accident or the effect could not be established; it was concluded that the root cause was probably a combination of both.

- Use studs made of stainless steel whose coefficient of thermal expansion is between those of aluminium and low alloy steel. This reduces the differential contraction.
- Follow ‘cold bolting’ practice strictly i.e. tighten the studs after temperature change
- Tighten the specifications for non-destructive examination of nozzle weld

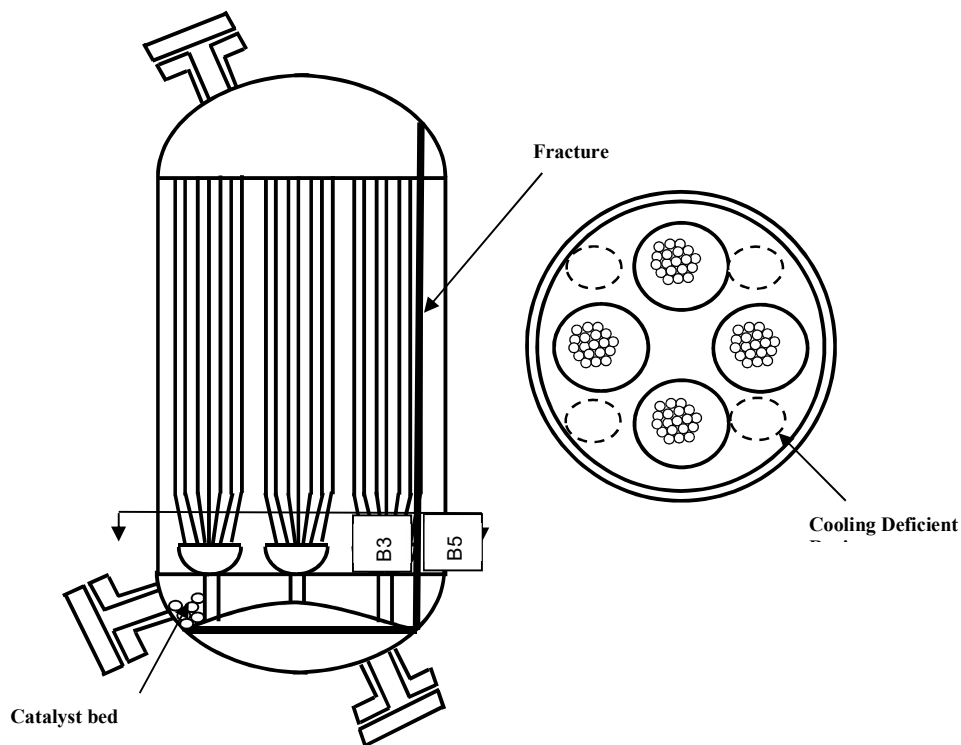
Fig. 2 – Schematic View of Methanol Converter Pressure Vessel

After about one year of operation, the 2.27 m diameter methanol converter vessel, designed for 90 Kg/sq.cm internal pressure and operating at 325 C, failed catastrophically. The vessel had split open and after flinging its contents, was catapulted to a distance of 80 meters.

Postulate	Investigation	Result
Gross material error	Chemical analysis	Ruled out
Error in heat treatment	Tensile tests	Tests show low strength near B3, B5 (See Fig. 2) but not low enough to fail at op. pr.
Gross design error	Stress analysis	Ruled out as Codal limits were satisfied
Material defect	Fracture mechanics evaluation	Critical crack size depth = 19 mm, length = 130 mm, Too large to escape detection
Overpressure	Burst pressure calculation	Burst pressure = 259 kg/sq.cm against design pressure of 90 kg/sq.cm Pressure record does not show any increase
Internal explosion	Examination of fracture edges	Occurrence of bulge and extensive thinning suggests slow deformation
External overheating	Burst pressure vs. temp. calculation	Temp. required for burst at operating pr. is ~ 700 deg C. Requires sustained fire
Internal overheating	Burst pressure vs. temp. calculation	Temp. required for burst at operating pr. is ~ 700 deg C. Possibility of local temperature rise due to methanation reaction

- Due to the degraded catalyst, a part of the vessel was operating at a higher temperature
- This portion of the vessel was supporting methanation
- Sustained high temperature resulted in lowering of strength
- The temperature reached the threshold for a runaway methanation reaction.
- Local temperature rose to a value at which the UTS of the material was exceeded.
- Bulging and thinning followed by rupture near B3, B5
- Unstable crack propagation through the length of the vessel

- The failure was due to a local temperature excursion due to methanation reaction.

- Avoid areas of cooling deficiency
- Temperature measurement at more locations
- Change the catalyst bed if it results in higher temp.

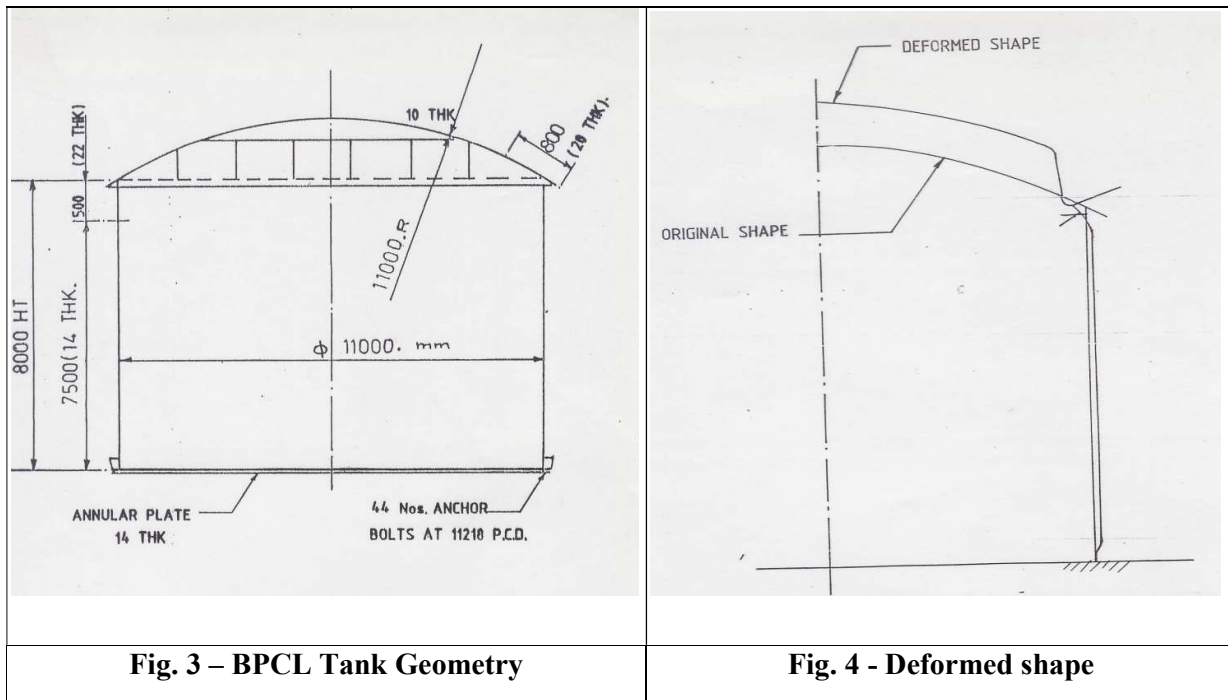
The results showed significant deformation at the shell-roof junction and consequent localized yielding, which commenced at a pressure of 0.6 kg/sq.cm. However, this is permitted by the codes and the tank, as designed, was safe for the design pressure of 1.0 kg/sq.cm.

- Failure was not due to any inadequacy in design
- Further investigation revealed that the tank was overfilled and consequentially over pressurized because of the faulty indication by tank level gauge.

- Follow code rules for pressure relief
- Avoid overpressurization during filling

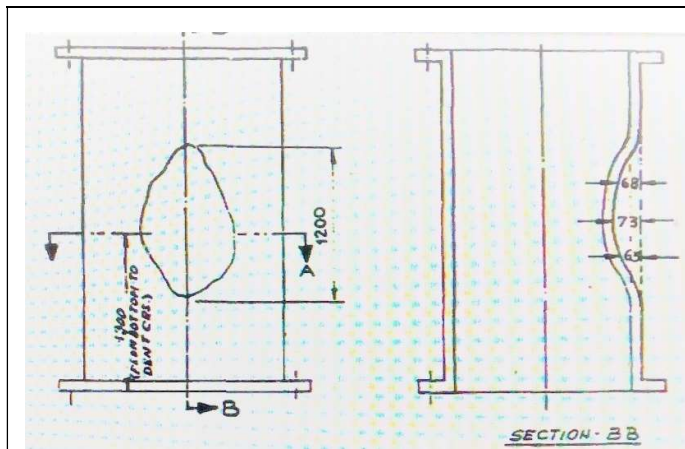
Fig. 5 - Dent on Stage No.6

During the annual shut-down in April-May 1991, tower was opened for maintenance; after it was depressurised purged and made ready for opening as per the procedure laid down for the purpose. Accordingly, the cover of the tower was lifted, kept aside and cable stage removed. When tower stages were removed one by one, stages 6th, 7th and 8th were found to be damaged. The damage was in the form of a 75 mm deep dent in each of the three shells. [6] (Fig. 5)

During investigation it was discovered that a lot of water was sprayed inside the tower to wash residual ammonia. A postulate that the dents occurred because of freezing of water in the annular space was investigated analytically as well as experimentally. Although it could be verified that the quantity of water sprayed was sufficient to fill the annular space and had in fact frozen (the temperature was below zero deg C); it was difficult to believe that a 30 mm thick shell could be damaged by this mechanism. To verify this, a scaled model of the tower-shell assembly (Fig. 6) was filled with water and put in a refrigerator. Next day, when the water in the annular space had frozen, the same dent appeared in the model. Thus it was conclusively demonstrated that this was indeed the cause.

A fitness-for-purpose evaluation was also performed using finite element method. It was found that for the intended service, the shells could be used without repair. The tower has since been put back into service and has been operating satisfactorily.

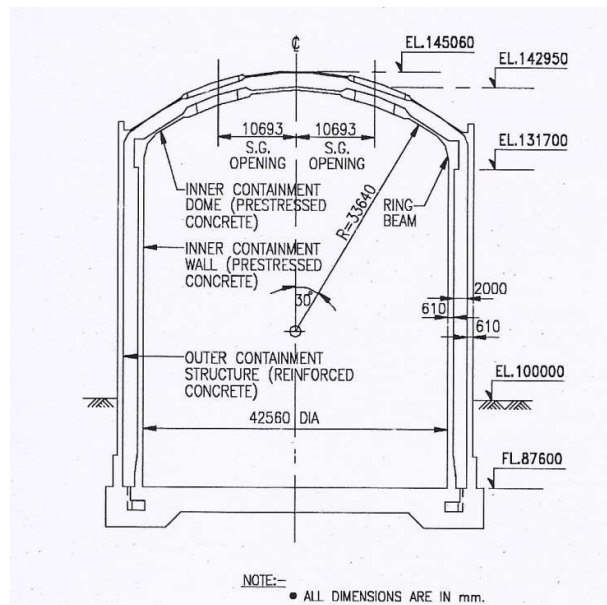
Fig. 7 – Cross Section of Containment Structure

On 13 May 1994, the inner containment dome of unit 1 of the Kaiga nuclear power plant collapsed during reactor construction. The dome itself had been completed but cabling and other tasks were being carried out. The failure was in the form of delamination. The under surface of the dome in the central portion delaminated and fell down completely. However, the upper portion had sufficient strength to hold itself in position under the action of its self-weight and whatever super-imposed load it had on it [7, 8].

These radial stresses coupled with congestion caused by large quantity of reinforcement and closely spaced prestressing cables were identified as root causes of the failure.

- (1) The intact portion of the dome to be demolished; extent depending on detailed examination
- (2) Measures to be taken in design:
 - a) increase of general thickness of dome from 340 to 470 mm;
 - b) to minimize the induced radial tension in the transition zones, the dome thickness to be increased gradually to the higher value of the thickened portion around the SG openings;
 - c) introduce radial reinforcement;
 - d) increase in minimum cable spacing from 108 to 225 mm to avoid congestion

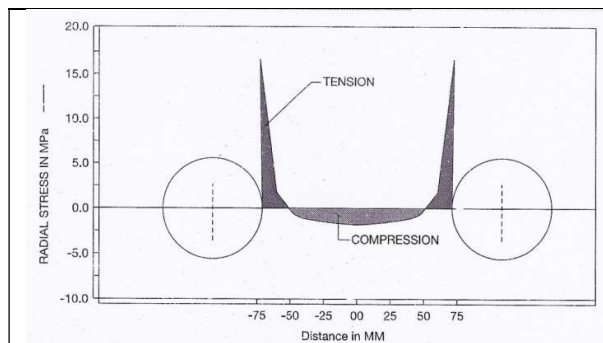
Fig. 8 – Radial Stress Distribution Near Penetrations

However, presence of local radial tensile stresses could not be ruled out; one of the sources being the stress concentration effect near an opening, Fig. 8.

1. The in-plane compressive membrane stresses also generate radial stress near the hollow sheath in the thickness of shell due to stress concentration effect, as brought out earlier
2. The curved prestressing cables exert pressure towards centre leading to development of radial stress
3. The radial stress is also generated where the shell thickness changes within a short distance

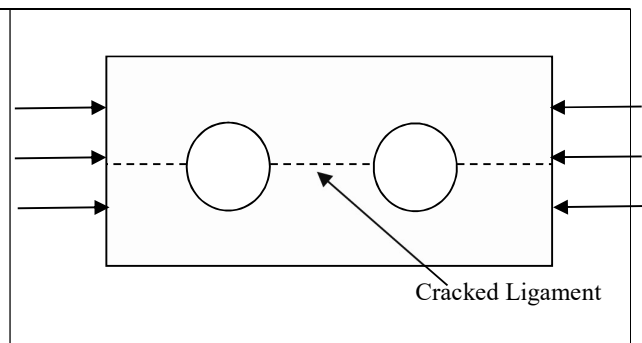
Fig. 9 – Simple Experiment to Demonstrate Delamination Phenomenon

Since these radial tensile stresses are localized in nature, there was hesitation in concluding that delamination was caused by them. In order to demonstrate that the radial stresses due to the stress concentration can indeed lead to delamination; an experiment was conducted using a Perspex sheet with two holes drilled into it (Fig. 9). The sheet can be visualized as a slice of the containment dome with the two holes simulating the sheath holes. The compressive load generated by the cables running transverse to the holes was simulated by clamping the sheet in a vice. On application of compressive load the ligaments between the holes and between the holes and the edges cracked, demonstrating the ability of the radial stress

to cause cracking. The sheet however, remained as a single piece showing the secondary nature of the radial stress which disappeared on cracking.

Notwithstanding the difference between the two materials viz. concrete and Perspex, the experiment did show the possibility of delamination, in principle. The process of delamination is aided by short spacing between the two openings, which was the case at the location of delamination.
